# 6.0L TURBOCHARGER CARBON DEPOSIT DIAGNOSTICS AND SERVICE TIPS—LACK OF POWER, WHITE OR BLACK SMOKE, SURGE, P0238, P0299, P0404, P0478, P2262, AND/OR P2263

TSB 07-16-1

**FORD:**  
2003-2005 Excursion

2003-2007 F-Super Duty  
2004-2007 E-350, E-450

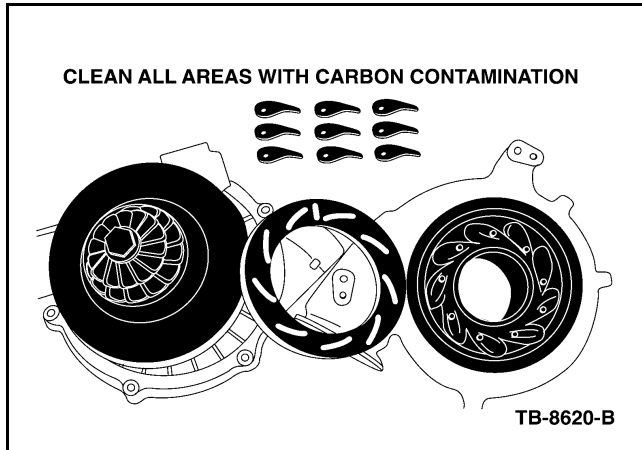
Figure 4 - Article 07-16-1

Coking deposits inside the turbocharger turbine housing can impede vane response causing high or low instances of exhaust pressure. Unexpected exhaust pressure results can cause over-boost, under-boost, insufficient or excessive exhaust gas recirculation, or unexpected EGR valve position, resulting in these symptoms.

8. Separate the housings by using a hammer and brass drift.
9. Separate vanes and unison ring from turbine housing and center housing and check for coking from oil. If turbocharger is coked with carbon deposits from oil, the deposits will be wet and black and cover the complete inside of the turbo (Figure 4) .

- a. If the turbocharger is oil coked, continue with this TSB.
- b. If the turbocharger is not oil coked, replace the turbocharger and do not continue with this TSB. This TSB is only for cleaning a turbo that is coked because of excess oil.

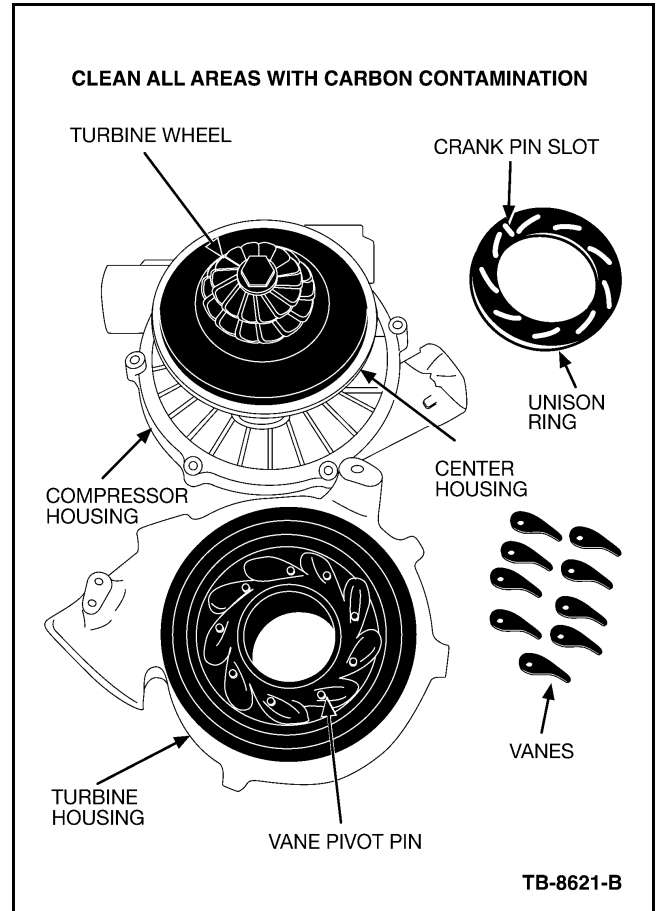
Figure 5 - Article 07-16-1

NOTE: AVOID DAMAGING VANE PIVOT PINS DURING THE CLEANING PROCESS. PIN DAMAGE CAN CAUSE UNWANTED NOISE AND/OR IMPAIR TURBOCHARGER PERFORMANCE (FIGURE 5).

10. Inspect the unison ring for cracks. Replace the turbocharger if the unison ring is cracked.
11. To clean the carbon deposits, wet the unison ring, vanes, and turbine housing and center housing unison ring and vane contact areas with Carburetor Tune-Up Cleaner (Figure 5).

12. Finish cleaning the center housing, unison ring and vanes with a Scotch-Brite™ 2" (5 cm) abrasive disc 051131-07480, or equivalent (obtain locally). Ensure these areas are free of carbon (Figure 5):
  - Center housing unison ring hub
  - Center housing facing surface
  - Unison ring inner diameter
  - Unison ring outer diameter
  - Unison ring facing surfaces
  - Unison ring crank hole

14. Finish cleaning the turbine housing using the modified disc. Remove the carbon deposits from all surfaces that contact moving parts, as well as the mating surfaces of the housing. (Figure 5 and 8)
