#PIP3394F: Duramax Diesel Injector Driver Codes - (Apr 24, 2013)

Subject: Duramax Diesel Injector Driver Codes
2004-2005 Chevrolet Kodiak, Silverado
Models: 2004-2005 GMC Sierra, Topkick
with 6.6 Engine (VIN 2 - RPO LLY)

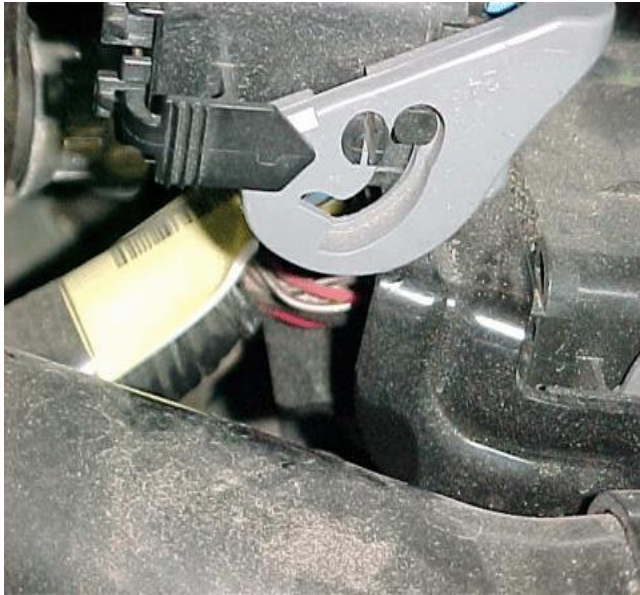
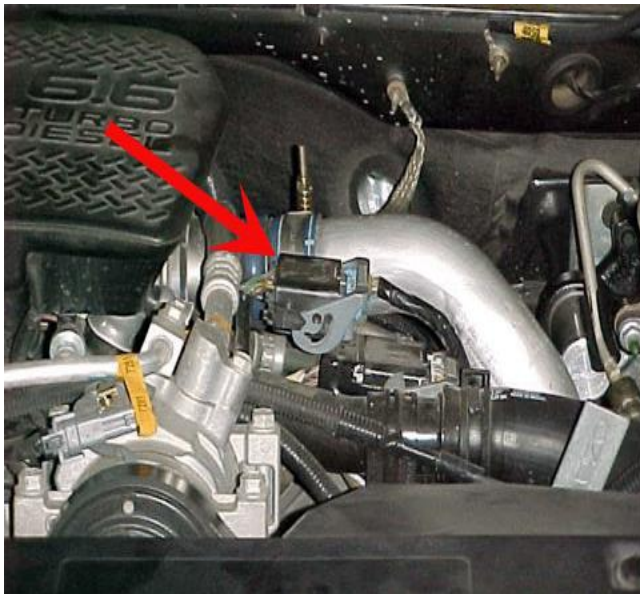
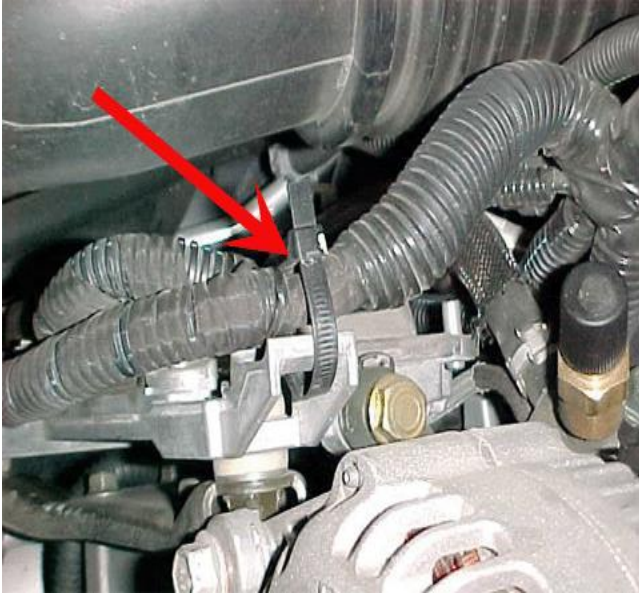
1. Diagnose all injector driver codes using the current SI diagnostics.
2. If all SI diagnostics are inconclusive, inspect for wire chafes at the Fuel Injector Control Module (FICM) wiring harness brace. The wiring harness brace is located 4 to 6 inches away from the FICM connectors. The wiring harness is nylon tied to the wiring harness brace. It may be necessary to remove the nylon tie to inspect the harness. Repair any wire chafes following SI wire repair procedures. Insulate the harness with wiring conduit or a suitable material so the wires will not chafe again.

3. Also inspect the C107 (Silverado and Sierra) or C118 (Kodiak and Topkick) connector for wire chafes. The C107 (Silverado and Sierra) or C118 (Kodiak and Topkick) connector is found above the left (driver side) rocker cover. The wiring harness may relax and lay on top of the C107 (Silverado and Sierra) or C118 (Kodiak and Topkick) support brace. This support brace is located right below the C107 (Silverado and Sierra) or C118 (Kodiak and Topkick) connector. Repair any wire chafes following SI wire repair procedures. Insulate the harness with wiring conduit or a suitable material so the wires will not chafe again.
