**SERVICE BULLETIN**

AT04-014

**4 SPEED AUTOMATIC TRANSMISSION HARSH 1-2 SHIFT  
AND/OR DTC P0745 STORED**

**APPLIED VEHICLES:** 2003 – 2005 Altima (L31)  
2003 – 2005 Sentra  
2003 – 2004 Maxima (A33 and A34)  
2004 Quest (V42)

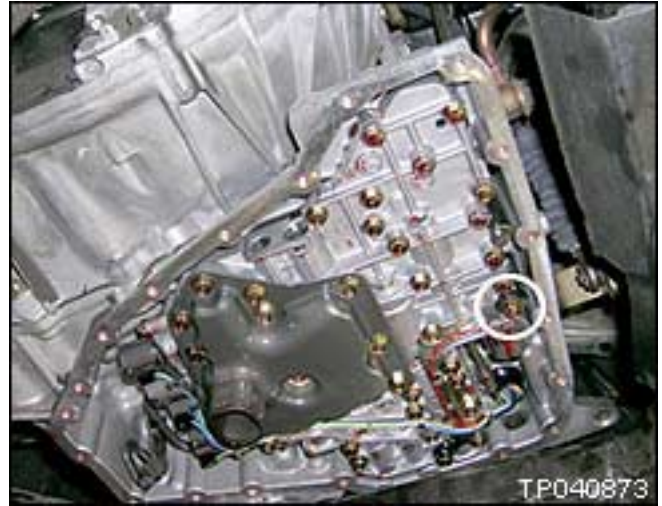
Figure 1

2. Locate the ground terminal for the line pressure solenoid.

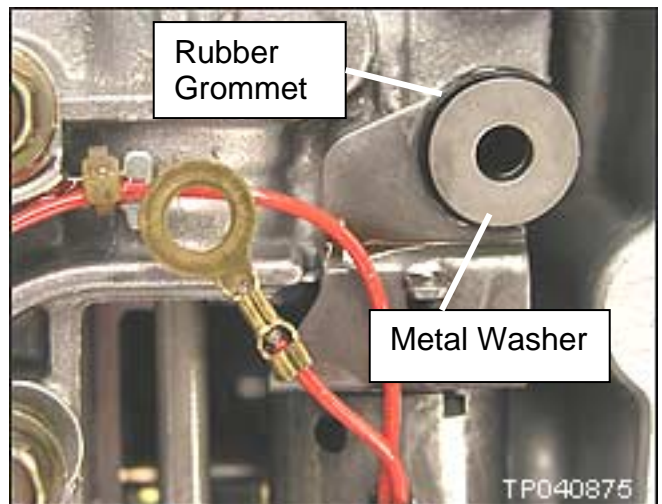
Figure 3

**IMPORTANT:** Make sure the metal washer that sits on the rubber grommet doesn't fall off.

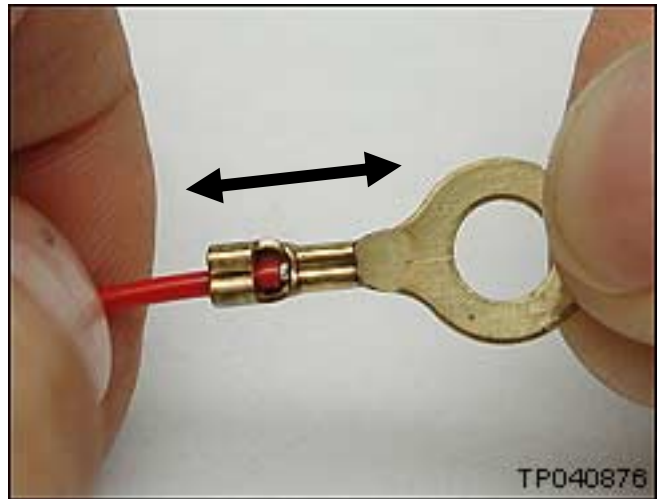
Figure 4

4. Make sure the ground terminal will not pull **completely** off of the wire.
- Use moderate force to pull / push the wire in and out of the terminal (no more than 5 lbs of pull force).
- a. If the terminal pulls completely off the wire with 5 lbs of pull force, replace the solenoid valve assembly (see Parts Information).
- Refer to the AT section of the appropriate Service Manual (ESM) for solenoid replacement.
  - Skip to step 11.

- b. If the terminal does not pull completely off of the wire, go to step 5 and continue with this procedure.

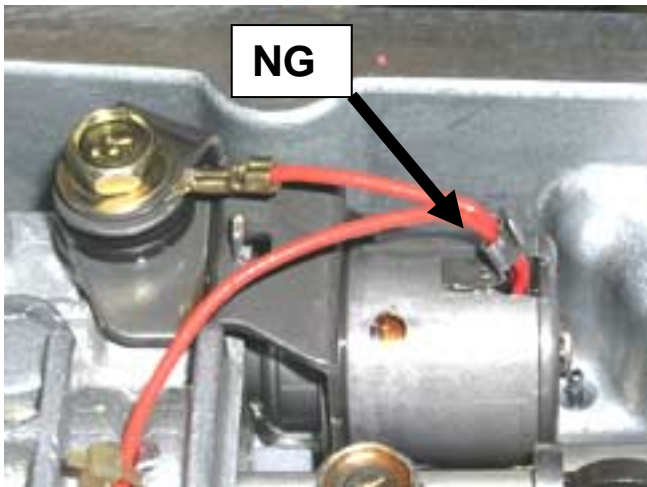
Figure 5a

5. Check the wire support crimp shown in Figure 5.

- If the support crimp is up as shown in Figure 5a, push it down as shown in Figure 5b.

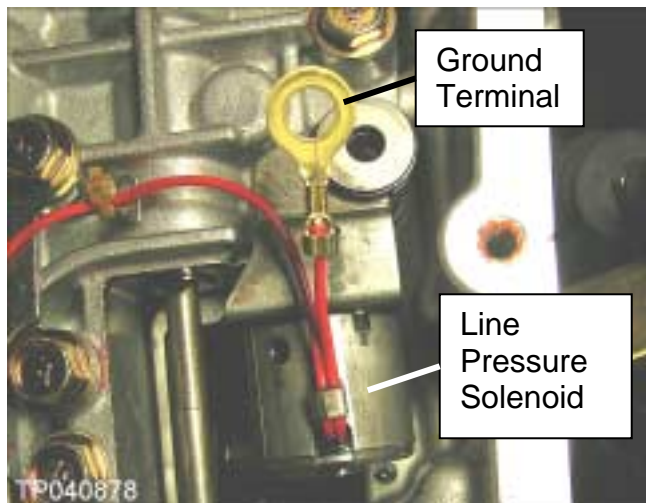
Figure 6

**IMPORTANT:** If the ATF is not completely cleaned off of the terminal, the solder will not stick correctly.

6. Completely wash the ground terminal with Electrical Contact Cleaner and blow it dry.

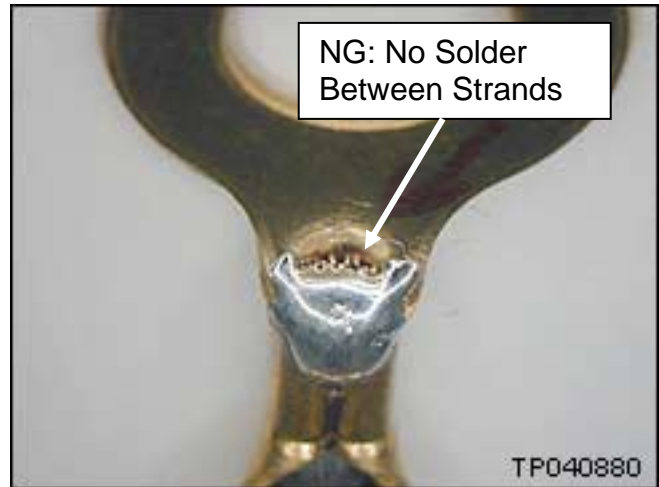
Figure 8

**NG:**

This is a “cold” solder. The solder did not flow into the crimp and between the wire strands.

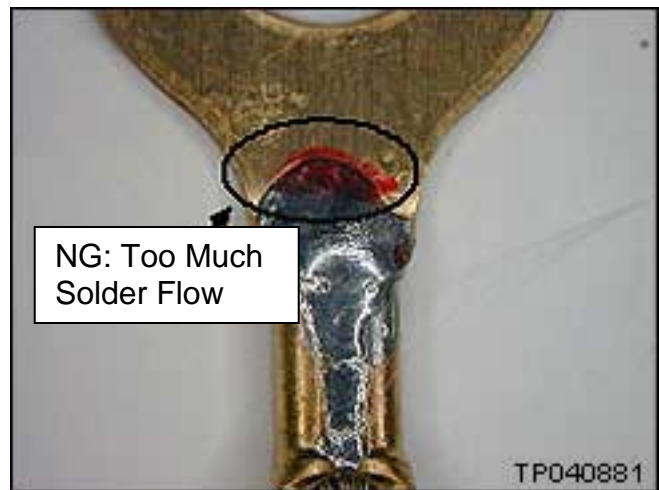
Figure 9

**NG:**

The solder flowed too far from the crimp and onto the terminal.

When the terminal is reinstalled the solder will be under the bolt washer and the washer will not seat flat.

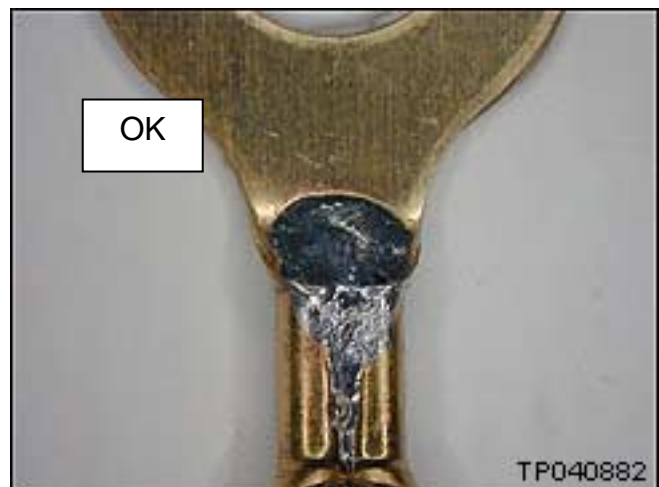
Figure 10

**OK:**

The solder flowed into the crimp and between each of the wire strands.

The solder is not too far out on the terminal.
