SERVICE BULLETIN

Classification: EC09-010	Reference: NTB09-046	Date: June 12, 2009
-----------------------------	-------------------------	------------------------

2004 – 2005 ALTIMA; DTC P0420 WITH SULEV QR25DE ENGINE

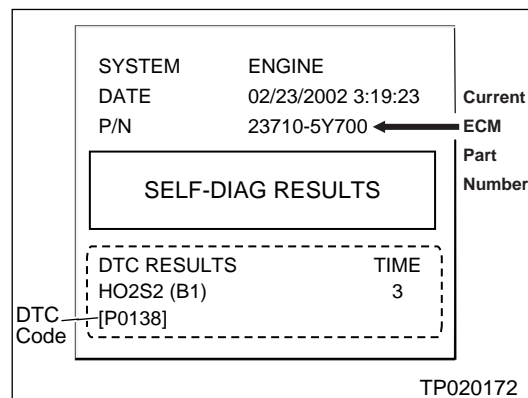
- Print out the CONSULT-II Self-Diagnosis results.
 - This print out will be used to check the ECM Part Number (determine if this bulletin applies).
 - Figure 1 is an example of the CONSULT-II Self-Diagnosis printout.

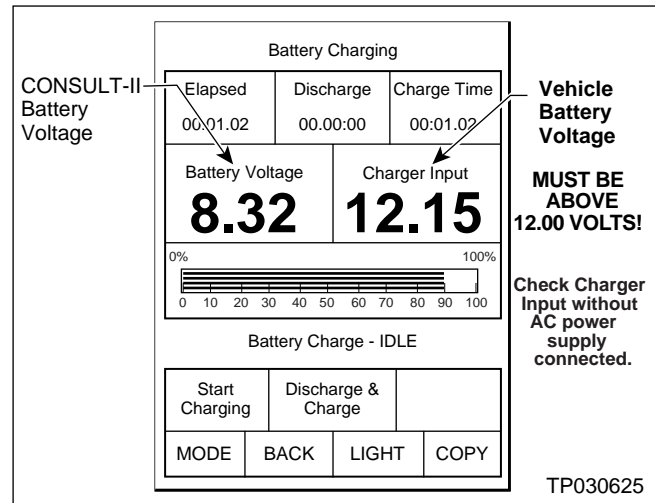
Figure D

- "Battery Voltage" is the voltage level of CONSULT-II's battery.
- "Charger Input" is the voltage level of the vehicle's battery. **(It must be above 12 volts.)**

3. Check the CONSULT-II's "Charger Input" reading (see Figure D).

CAUTION: If the "Charger Input" is below 12 volts:
